# Fillmore and Piru Basins Groundwater Dependent Ecosystems

Christian Braudrick and Bruce Orr  
Stillwater Sciences

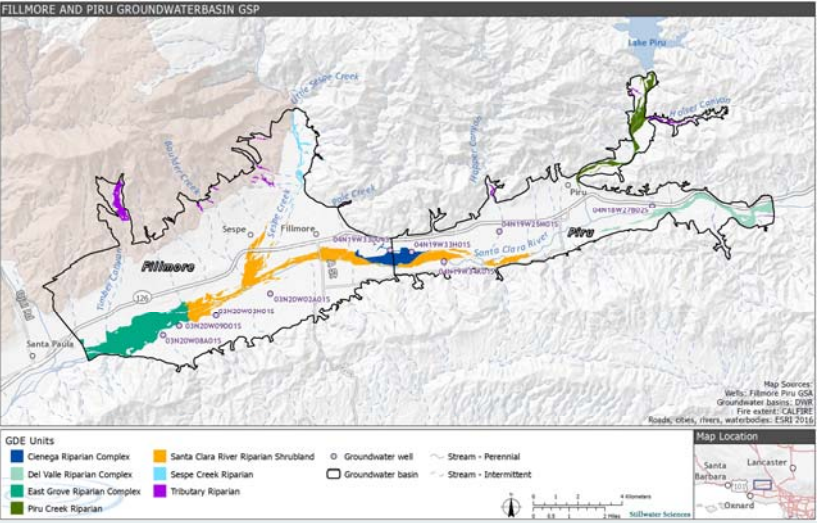
**Tributary riparian**

- (mostly oaks, little groundwater data)
- deep roots (30 ft) little groundwater data
- No shallow groundwater measurements.
- Unlikely to be affected by groundwater management

**Sespe Creek Riparian**

- (cottonwood, willow, arundo).
- Shallow groundwater unknown
- rooting depths of willows and cottonwoods = 7 ft, average relative elevation is 10 ft in SCR.
- Few shallow groundwater measurements

**Piru Creek Riparian**

- Cottonwood, willow (roots 7-10 ft) and mulefat (root depth 2 ft)
- Releases from Santa Felicia Dam
- Few shallow groundwater measurements

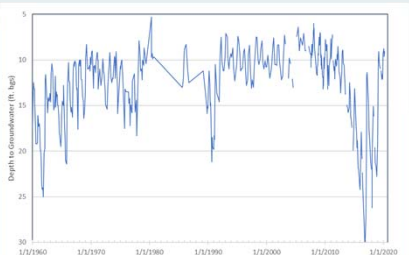
**★ East Grove**

The east grove well is 10-20 ft above the GDE elevation
