# Fillmore and Piru Groundwater Basins Monitoring Program and Data Gap Analysis Technical Memorandum

Fillmore and Piru Basins  
Groundwater Sustainability Agency

**DBS&A**  
*Daniel B. Stephens & Associates, Inc.*

December 16, 2021

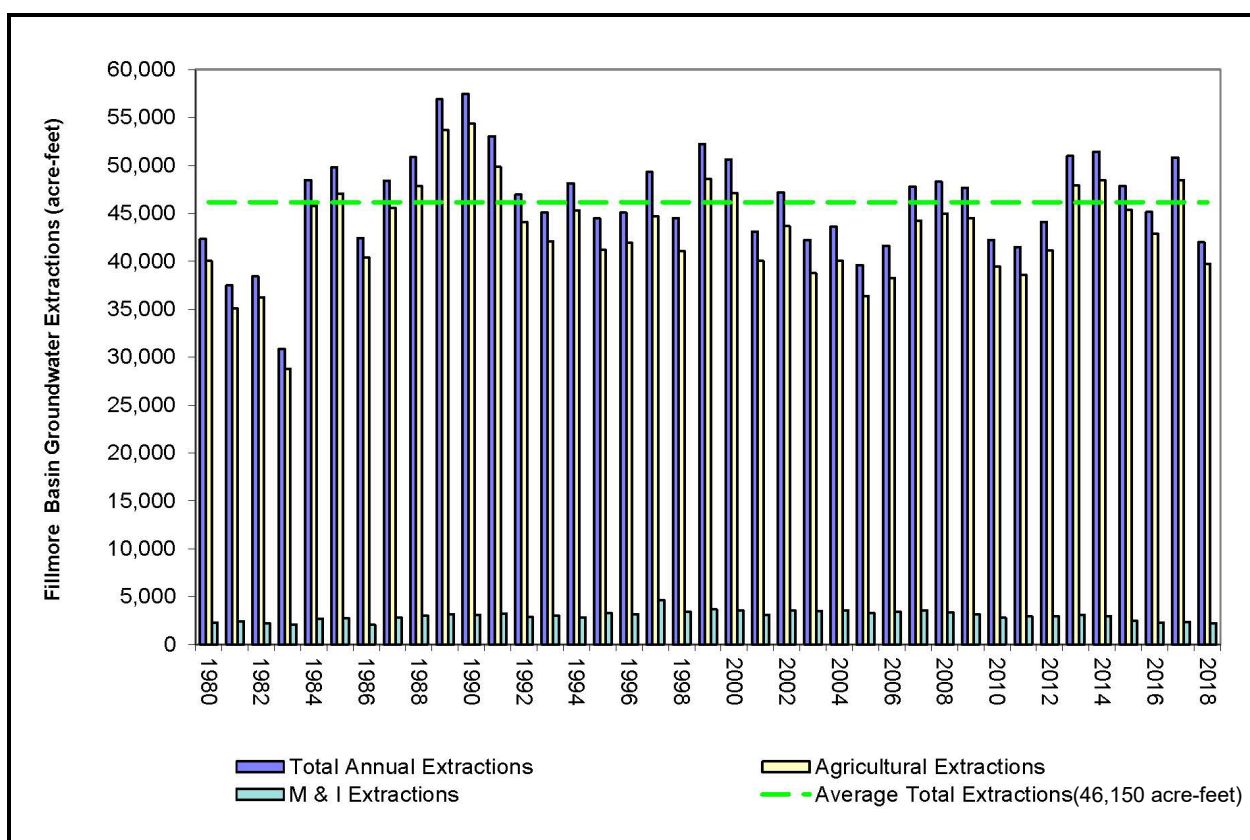
**Figure 2-2: Historical annual calendar year groundwater extractions (reported to UWCD) for the Fillmore basin using DWR 2019 basin boundaries.**

In calendar year 2018 a total of 41,977 AF of groundwater extraction was reported for the Fillmore basin from 301 wells. This is 4,173 AF less than the historical average of 46,150 AF (1980 through 2018). Agricultural uses accounted for approximately 95 percent of the

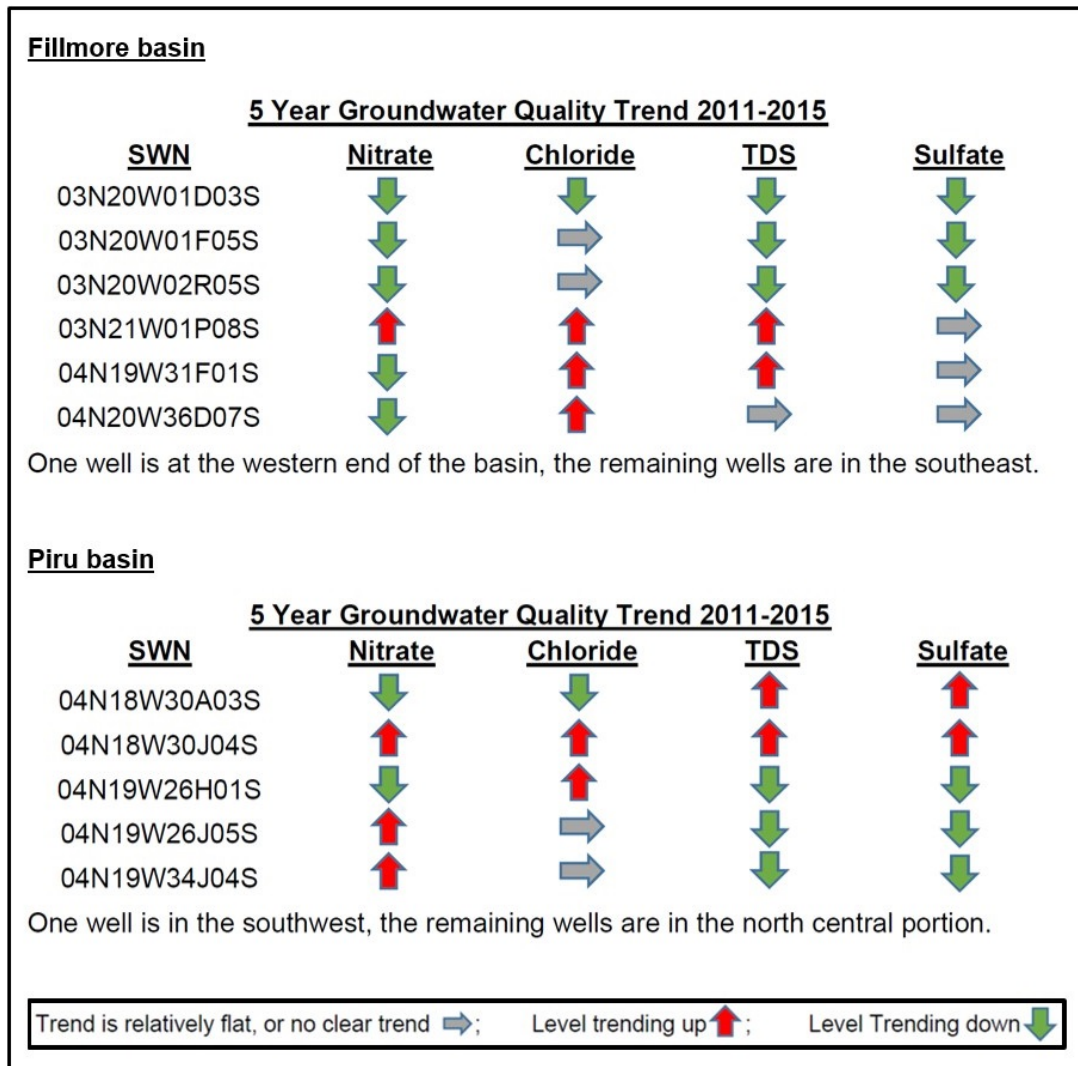
The five primary chemicals of concern analyzed in this Section have been used historically as water quality indicators of the “health” of the basins. Both UWCD and VCWPD have traditionally reported on the trends of these analytes in annual or biennial reports, with the exception of boron in which only UWCD has systematically reported. VCWPD reports the groundwater trends of six wells for Fillmore basin and five wells in Piru basin for the period from 2011 to 2015 in their most recently published Annual Report of Groundwater Conditions (VCWPD, 2016). These trends are shown graphically in Figure 4-3.

**Figure 4-3: Fillmore and Piru basins five year groundwater quality trend 2011-2015. Modified from VCWPD Basin Summary Sheets (summary pages v and vii) from the 2015 Annual Report of Groundwater Conditions (VCWPD, 2016).**
