Re: Public Comment Letter for the Fillmore Basin Draft GSP

We appreciate the opportunity to comment on the Draft Groundwater Sustainability Plan (GSP) for the Fillmore Basin being prepared under the Sustainable Groundwater Management Act (SGMA). We are a group of academic scientists conducting research on the Santa Clara River (SCR) to understand groundwater dependent ecosystem responses to groundwater elevations and drought. This research is part of a \$2.5 million suite of projects that we currently have funded to develop water stress indicators (WSIs) for dryland riparian forest ecosystems threatened by climate change and increasing human water demand.

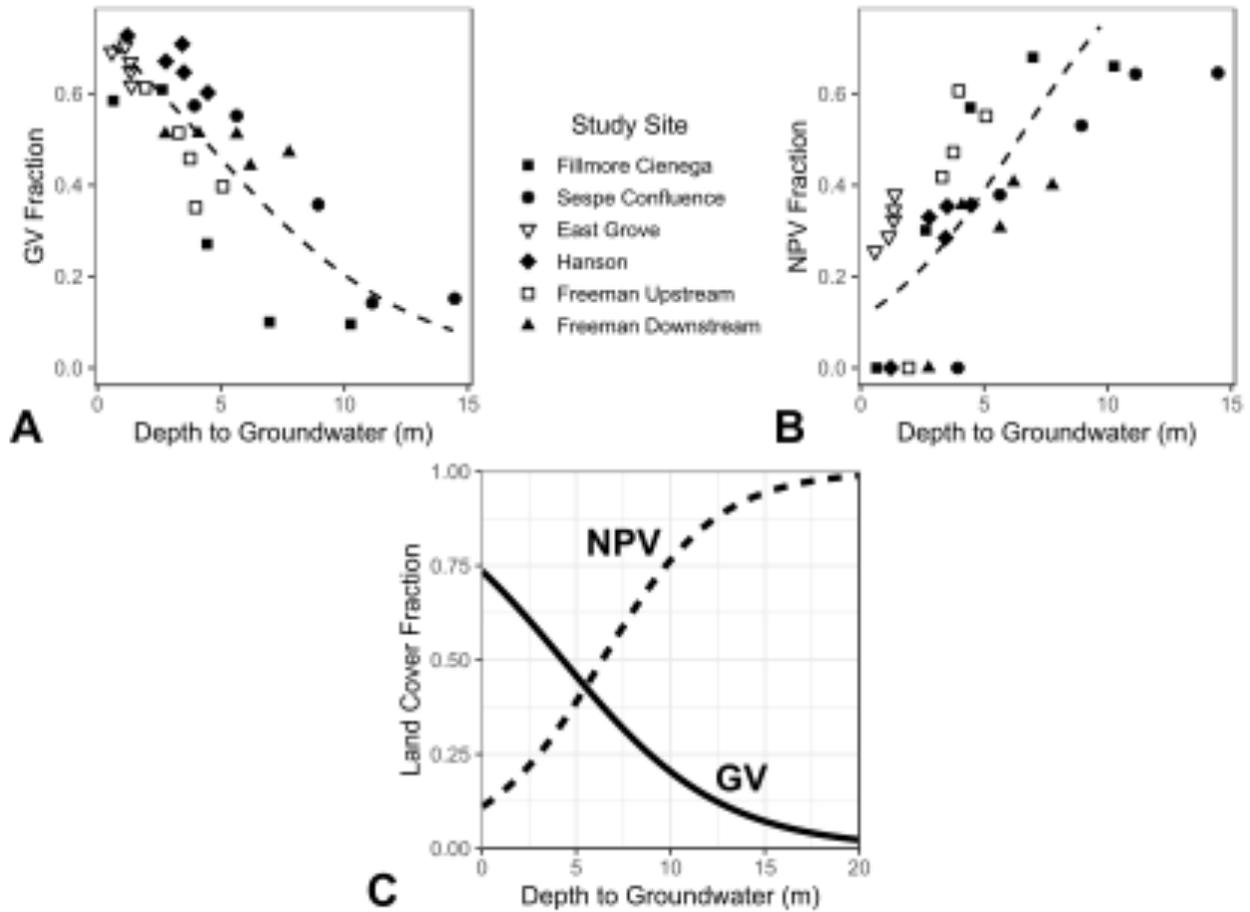
Figure 2. Plots showing the influence of groundwater depth on riparian woodland canopy health along the Santa Clara River before and during the 2012-2019 drought. The data are from [Kibler et al., 2021](#) in the journal *Environmental Research Letters*. Panel A shows the land area fractions of healthy green vegetation (GV) as a function of groundwater depth across six sites along the SCR. Panel B shows the fraction of non-photosynthetic vegetation (NPV) with groundwater depth at the same sites, indicating that the amount of canopy die-back increased as the groundwater level dropped. Panel C shows statistical models for GV and NPV based on the same data.

*below the surface, riparian trees demonstrate pronounced reductions in canopy greenness and growth, and increases in dead vegetation (Figures 1 and 2). Prior to that point however, a high rate of groundwater decline reduces the physiological functioning of the trees (Figure 3), imposing strong physiological stress that makes them vulnerable to cavitation (formation of air bubbles in the xylem, which kills them) and to attack by insects, pests and other risk factors. Often the reported maximum rooting depth for species is not realized under field conditions, because mature trees are adapted to the local groundwater depth and dynamic hydrological regime under which they developed. Even shallowly-rooted trees can become stressed when the groundwater drops more quickly than they have the capacity to adapt to, and it typically takes years -- if it is possible at all -- for trees to grow deeper roots, even for highly adaptable species. **Therefore these two factors, absolute groundwater depth and groundwater decline rate, should be factored into GSP guidelines to support groundwater-dependent tree species.***

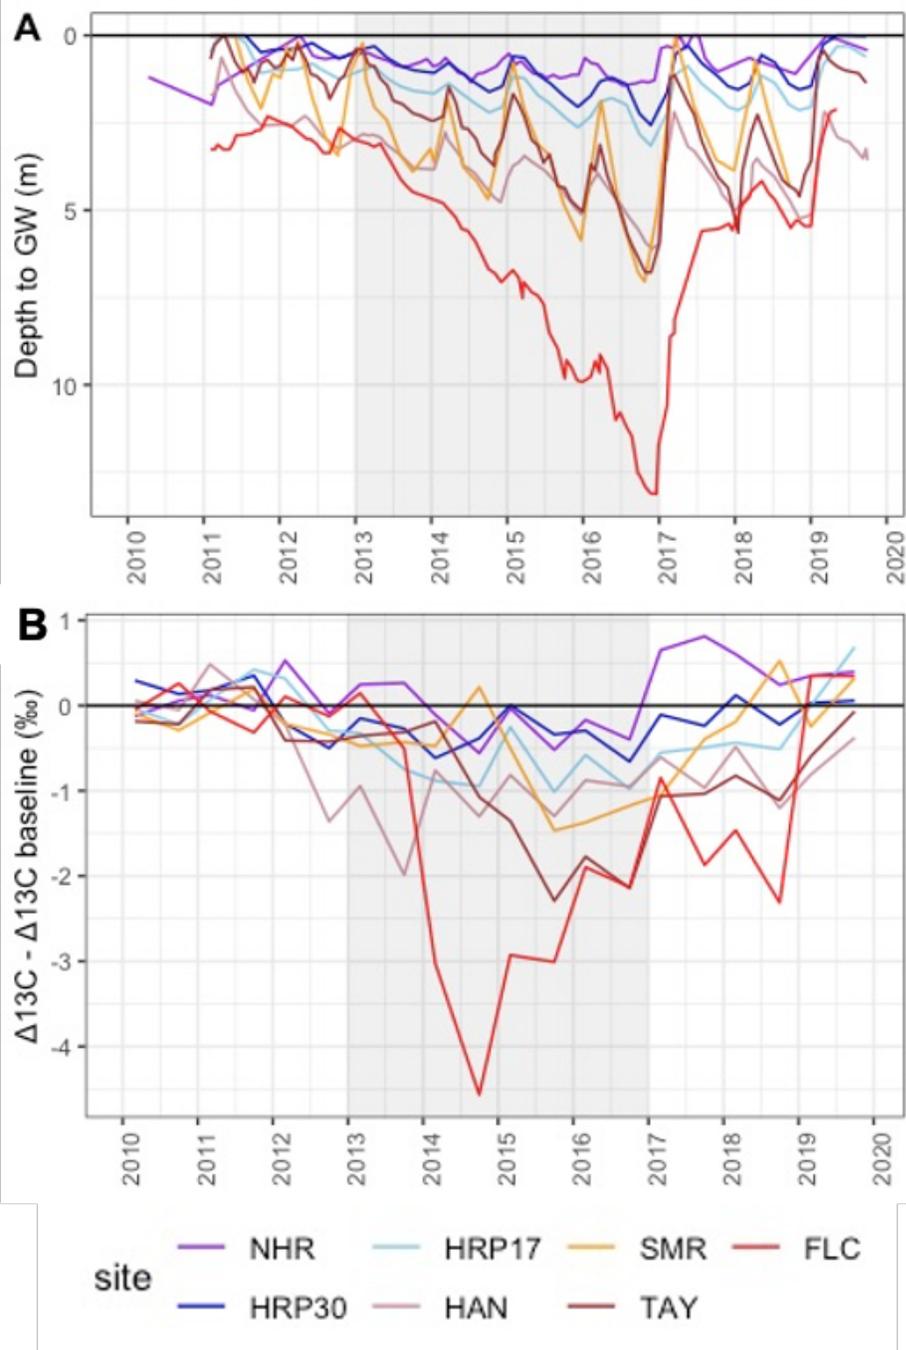
Figure 3. Line graphs from J. Williams, in prep.) showing the change in depth to groundwater at seven sites along the river (Panel A), and the change in physiological function of the trees over the same period based on tree ring stable isotopes of carbon (Panel B). More negative changes in the isotope values reflect greater water stress and a stronger response by trees. Shaded areas in both panels indicate the peak drought period of 2013-2016. Sites listed in downstream order are as follows: Newhall Ranch (NHR), Fillmore Cienaga (FLC), Taylor (TAY), South Mountain Road (DMR), Hedrick Range Lower (HRL), Hedrick Range Upper (HRU), and Hanson (HAN).

2. **The groundwater decline causes more water stress to riparian vegetation than climatic variables.** Tree-ring analyses confirmed strong reductions in radial growth and in carbon isotope discrimination, which represents prolonged closure of stomata (leaf pores) due to water stress (Figure 3). Together, these responses indicate that severe drought stress occurred within this GDE. We also found that these stress responses in riparian trees were driven more by the rate of groundwater decline than by meteorological variables (e.g., precipitation, air temperature). This analysis also showed that immediately after the drought, during which many trees died in the areas of greatest groundwater decline, the surviving trees showed strong recovery of both growth and leaf function (open stomata) where the groundwater level rose again and stayed within several meters of the surface during the subsequent growing seasons (Figure 3). This suggests a degree of resilience to water stress when groundwater decline is less severe, except at sites subjected to the greatest water stress. This research, led by PhD student Jared Williams and academics at SUNY-ESF and UC Santa Barbara, is currently in preparation for submission to a scientific journal (Williams et al., in prep.).
