Technical Memorandum

Subject: Fillmore and Piru Groundwater Basins 2022 Subsidence Update, prepared for Fillmore and Piru Basins Groundwater Sustainability Agency, DB22.1164.00

FILLMORE AND PIRU GROUNDWATER BASINS
SUBSIDENCE UPDATE
InSAR Monitoring Locations

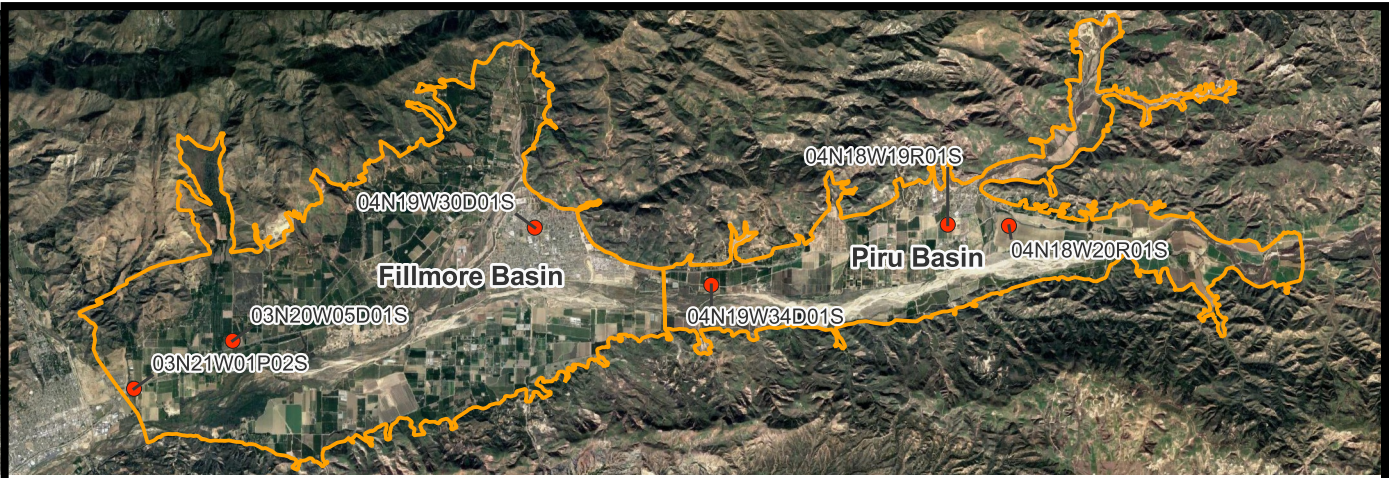
Figure 5 shows the location of nearby CGPS stations, along with time series graphs displaying measured land displacement relative to the first measurement of each station. Data displayed in the time-series graphs are referenced to the North American tectonic plate (NAM14) reference frame. Measurements with a standard deviation greater than 20 mm (about 0.8 inches) were considered to be outliers and removed from analysis.

Data from the two CGPS stations within the basin shows either no significant elevation change or a slightly increased elevation of approximately 20mm over the last 20 years. The two CGPS stations to the south of the Fillmore and Piru basins show a slight decrease in elevation over the last 20 years (10-20mm or 0.4-0.8 in), which is considered to be minor and related to natural tectonic motion as opposed to land subsidence due to groundwater pumping.
